# Manhole Inspection Summary

Manhole # S15E1\_001MH

Insp Date: **5/23/08 2:33 PM**

**Location** Address: **3100 washington bd**

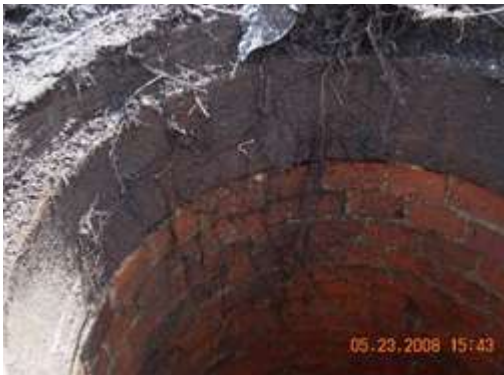
Defect 2

Condition: ☐ Sound ☐ Cracked ☒ **Root Intrusion** ☐ Loose Brick ☐ Deteriorated

root intrusion of frame/corbel joint

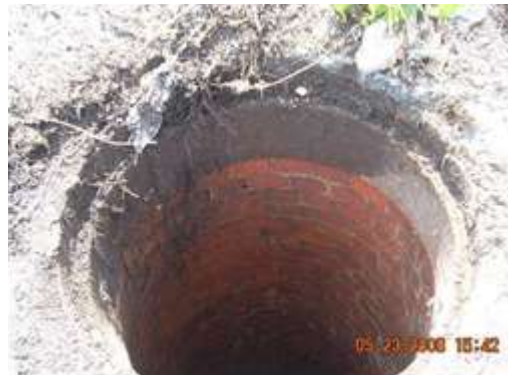
Defect 1

Subject To Ponding: **Sheeting**

inflow evidence from sheeting, frame leaks

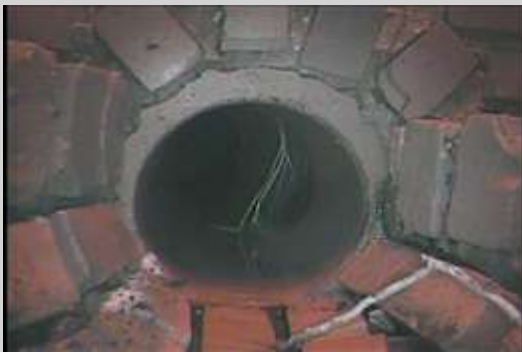
12 O'Clock Outflow

8 in. Circular Gravity Sewer  
Pipe Out @ 12 O'Clock

Pipe Height: **8.4** (in.) Rod and Bar (Angled)  
Pipe Material: **Clay** ☐ Pipe Lined  
Invert Depth: **11.55** (ft.) Flow Characteristics: **Slow**  
Deposits: ☒ None ☐ Mud ☐ Sludge ☐ Debris ☐ Grease  
Silt Depth: **0** (in.) Deposits Extent:  
Infiltration: **None** Pipe Seal Cond: **Sound**

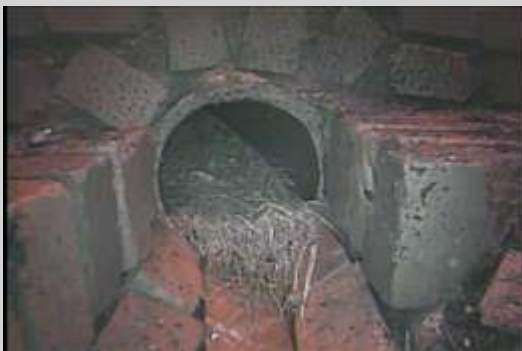
4 O'Clock Inflow

6 in. Circular Gravity Sewer  
Pipe In @ 4 O'Clock

Pipe Height: **6** (in.) Rod and Bar (Angled)  
Pipe Material: **Clay** ☐ Pipe Lined  
Invert Depth: **11.10** (ft.) Flow Characteristics: **Slow**  
Deposits: ☐ None ☐ Mud ☐ Sludge ☒ **Debris** ☐ Grease  
Silt Depth: **2** (in.) Deposits Extent: **Medium**  
Infiltration: **None** Pipe Seal Cond: **Sound**

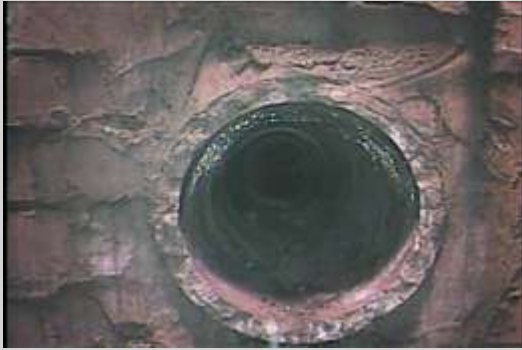
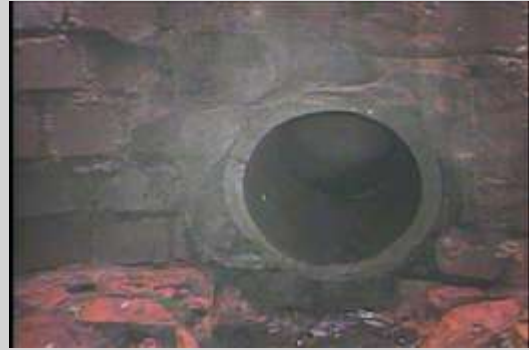
6 O'Clock Inflow

Pipe In @ 6 O'Clock

Drop In @ 6 O'Clock

Pipe Height: **8.4** (in.) Rod and Bar (Angled)

Invert Depth: **7.00** (ft.) Flow Characteristics: **None**

Drop: **Outside** Rod and Bar

Drop Condition: **Open**

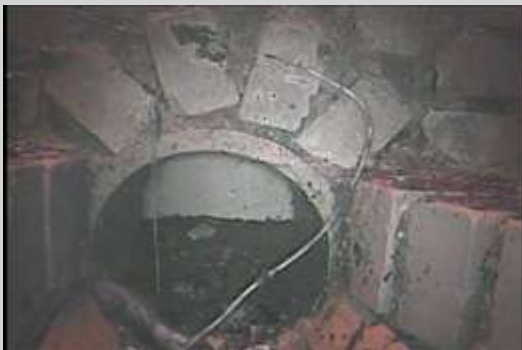
9 O'Clock Inflow

Pipe In @ 9 O'Clock

Pipe Height: **3.6** (in.) Rod and Bar (Angled)

Connects To: **Stub connection / abandoned**
